## **Volunteer Fire Fighter Killed While Walking Across an Interstate Highway Responding to a Motor Vehicle Incident - Texas**

## Fatality Assessment and Control Evaluation Investigative Report #F2003-13

### ***Volunteer Fire Fighter Killed Walking Across an Interstate Highway Responding to a Motor Vehicle Incident - Texas***

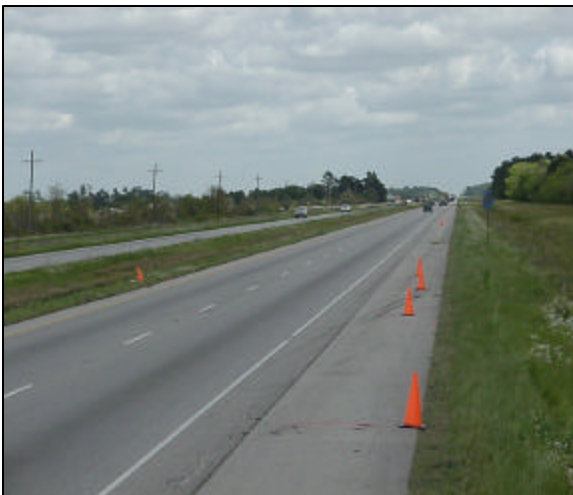
*Interstate highway eastbound lanes*

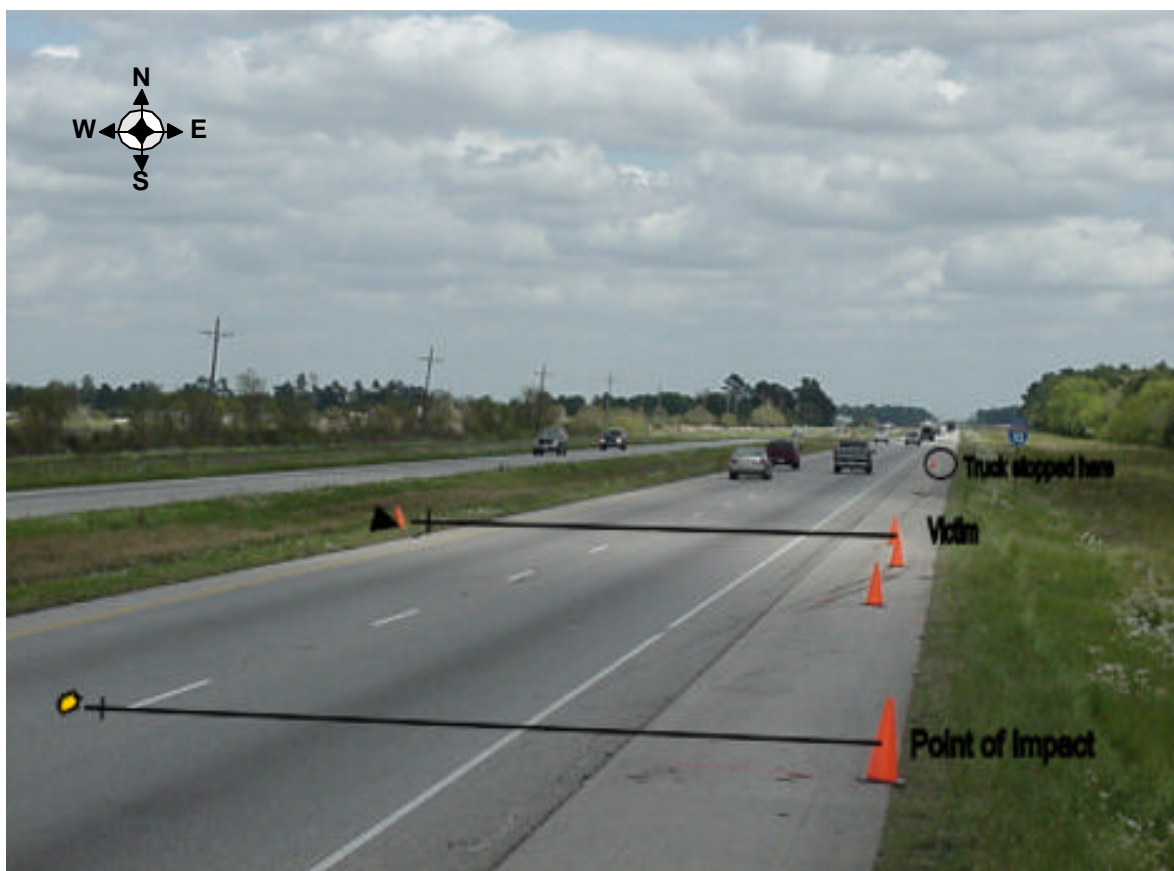
*Photo 1. Interstate eastbound lanes where victim was struck*

The incident occurred at approximately 0259 hours with light fog in the area. According to the National Weather Service, the temperature was approximately 61 degrees and dry. The incident occurred on a four-lane interstate highway with no roadway lighting (Photo 1 and Diagram). The highway is level and straight with narrow asphalt shoulders on the inside and the outside of the pair of lanes. The posted speed limit is 65 miles per hour.

According to the State fire marshal's report, the victim was struck by the tractor trailer on the right side of the front bumper of the passenger side. He was thrown onto the grass median approximately 170 feet east from the point of impact (Photo 1). The tractor trailer truck stopped approximately 598 feet down the highway from where the victim was struck. There were no skid marks from the tractor trailer on the highway from before or after the victim was struck. After the incident occurred, a reflectorized vest was found hanging from the rear-view mirror in the victim's POV.
